STONHARD SPOTLIGHT

STONHARD PROVIDES ULTRA-DURABLE, HYGIENIC FLOOR AND WALL SOLUTIONS FOR PHARMACEUTICAL COMPANY

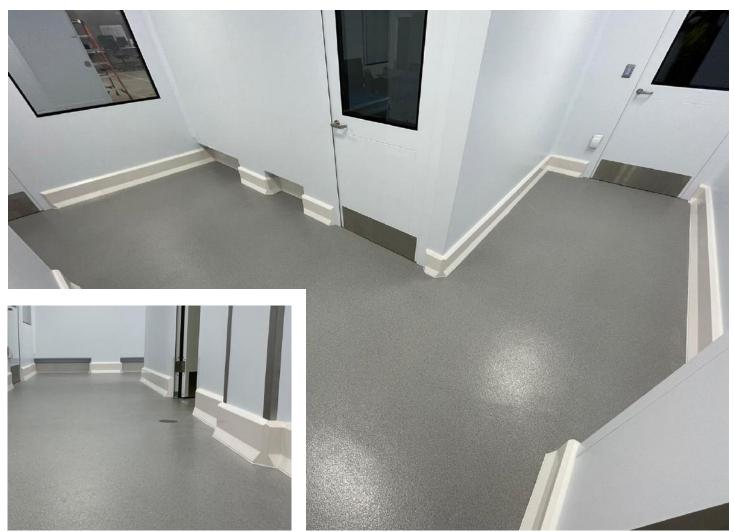
Problem: Renovation caused imperfections in concrete and customer needed a hygienic solution at the walls

Product Solution: Stonshield®HRI with Stonseal®CA7 and Polysto®OP20F

Scope of work: Fill suite and support rooms

Stonhard knows that pharmaceutical require high-performing, snaces innovative solutions to keep their operations running smoothly and safely. When a global pharmaceutical company was making renovations on their Texas facility's fill suite and support rooms, they came to Stonhard to solve their problems and ensure an effective, longterm solution. During the renovation of the fill suite, all the walls were removed, and patching was required where the walls once stood. Stonhard applied a quarter inch mortar base to level out imperfections in the concrete and the different elevations between old rooms

and walls. Stonshield®HRI was chosen by the customer for its decorative quartz aggregate, durability, and chemical and stain resistance.

In addition to a flooring system, the customer was looking for an alternative to the stainless-steel bumper rails they had used to protect walls from damage by carts. Cleaning behind these rails was difficult. Stonhard, the exclusive turnkey partner of Polysto® in the United States, installed OP20F, a prefabricated, exceptionally durable, water-resistant curb system that provides sanitary design, a seamless transition from floor to wall, and a system that is much easier to clean.
